Continuation from previous Newsletters: Pruning Wild Apple Trees with Bruce Robinson

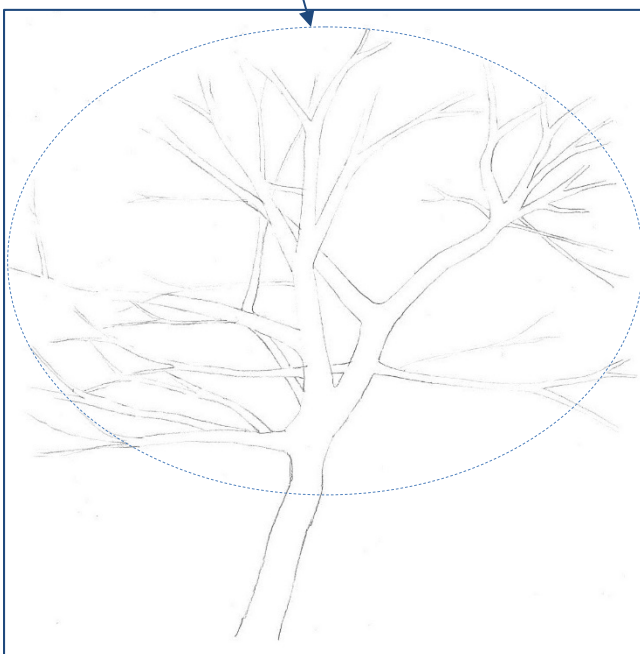
The team working-on this tree took several minutes to look it over and decide what, if any, work was needed. They concluded that the overall form of the crown was already pretty good. However, there were some structural issues amongst the branches. Also, the crown was overly dense; less than ideal for fruit production.

This tree's crown already had good general form; crown spread was a little more horizontal than vertical.

1. Decrease the density of the crown for better light and air circulation.
2. Eliminate crossing branches and provide adequate spacing to avoid rubbing injuries and structural problems.

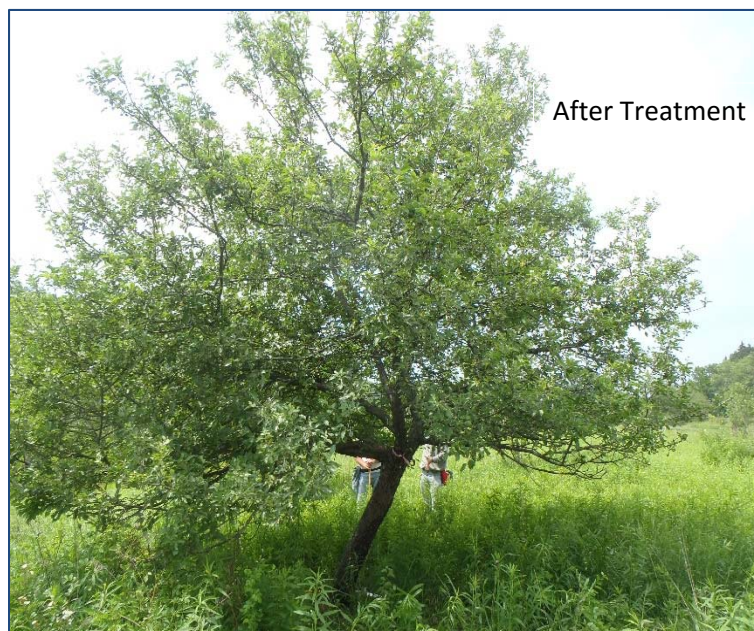
A noticeable change in crown density was accomplished without changing the crown's form.

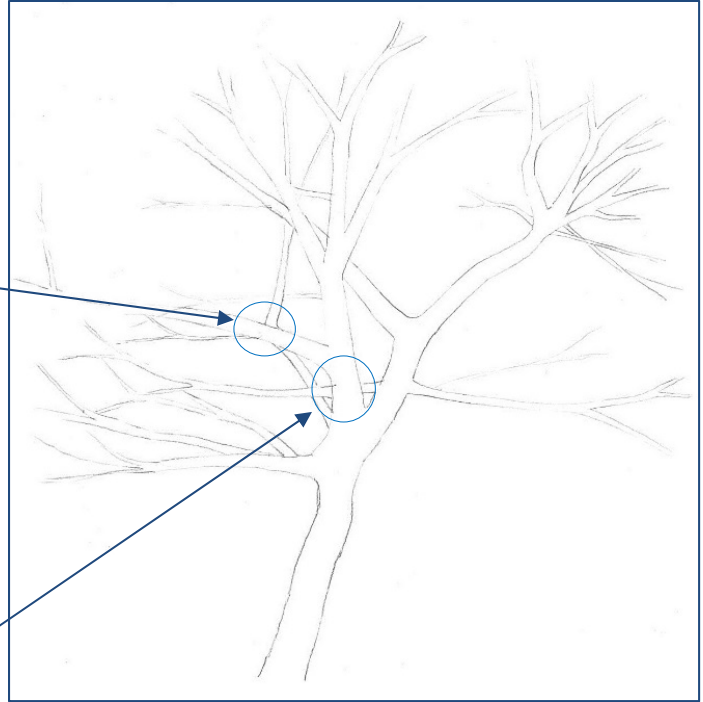
This branch was removed because it was contacting a better branch and competing for light higher in the crown. (Picture from backside of tree)

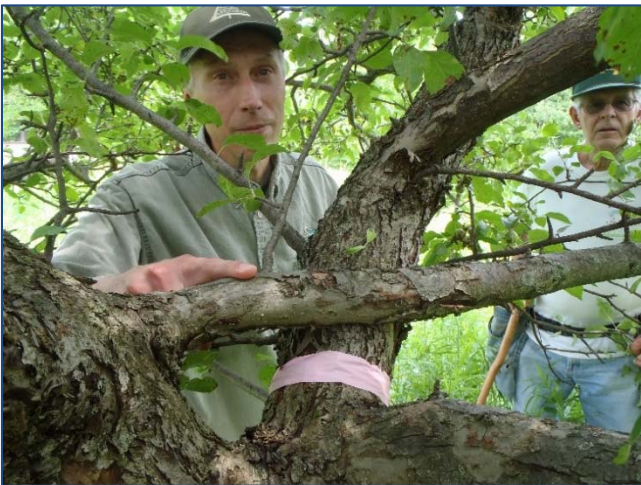
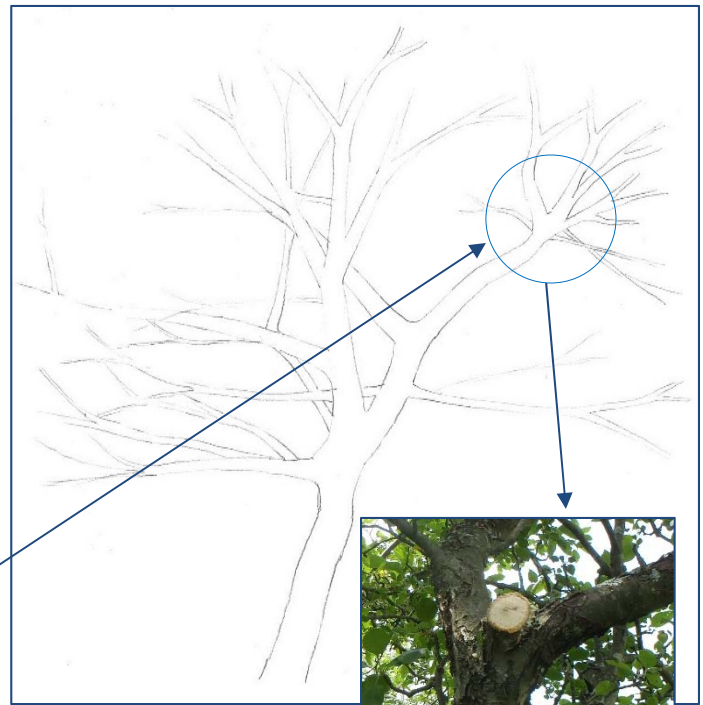
Another crossing branch. Bark injury occurred where the branches were in contact. (Picture from backside of tree)

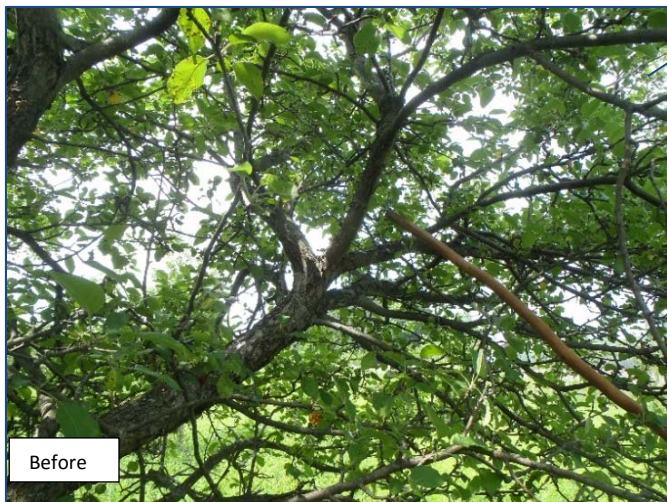
Before

Numerous lateral branches were crowding this portion of the crown. Two branches were removed in order to provide better spacing while also reducing crown density.
